ALCOA RESEARCH LABORATORIES

INVESTIGATION OF THE MECHANISM OF
STRESS CORROSION OF ALUMINUM ALLOYS

Bureau of Naval Weapons Contract NOW 65-0327-f

Final Report

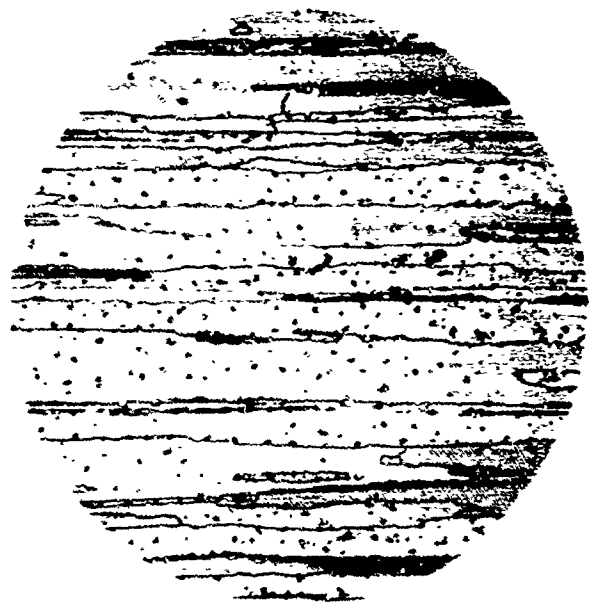
- A. 7075-T6 alloy plate.
- B. Nominal 7075-T6 alloy forging.
- C. Recrystallized 7075-T6 alloy forging.
- D. High purity 7075-T6 alloy forging.
- E. Nominal 7075-T6 - Cr alloy forging.
- F. High purity 7075-T6 - Cr alloy forging.

(The fabrication procedures were selected to yield recrystallization in (C) but not in (B). Actually, both forgings recrystallized during solution heat treatment.)

The chemical analysis of the four melts used for the five forgings are listed in Table I. Typical microstructures in the -T6 temper are illustrated in Figure 1. Tensile properties and electrical conductivities are listed in Table II.
